**Flood Control Project Maintenance
Levee Inspections**

Maintenance Issue Types Only, Levee Inspection Report By Mile - Spring 2018

Reclamation District No. 0001 Union Island

Waterway	Bank	Unit Miles	Inspection Start/End	Inspector
Unit No. 01 Old River	Right	1.14	05/17/2018 05/17/2018	Richard Willoughby

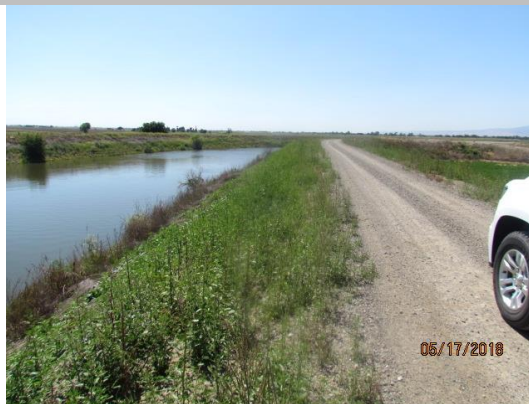
Photo 1 of 1 : SP_2018_RD0001_23_13_20180521_00017.jpg

LM Start	0.00	Rating **	M	Issue No.	13
LM End	1.14	Issue Type +	Ma	Location *	WS
Category	Earthen Levee		GPS Latitude/Longitude		
			Start	End	
Item	Vegetation		37.822517°	37.811681°	
			-121.375506°	-121.384967°	
DWR ID	DWR_RD0001_01_s_2018_13				
Comment Code					
V1 : Control annual grass and weeds on the levee slopes and easements.					
Inspector Comment

Looking at typical view of waterward slope.

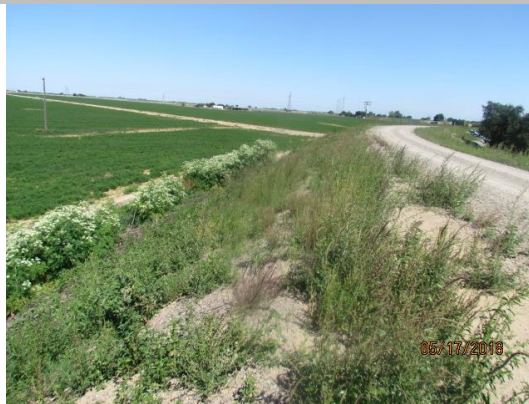
Photo 1 of 1 : SP_2018_RD0001_23_2_20180521_00018.jpg

LM Start	0.00	Rating **	M	Issue No.	2
LM End	1.14	Issue Type +	Ma	Location *	LS
Category	Earthen Levee		GPS Latitude/Longitude		
			Start	End	
Item	Vegetation		37.822516°	37.811680°	
			-121.375506°	-121.384968°	
DWR ID	DWR_RD0001_01_s_2018_2				
Comment Code					
V1 : Control annual grass and weeds on the levee slopes and easements.					
Inspector Comment

Looking at typical view of landward slope.

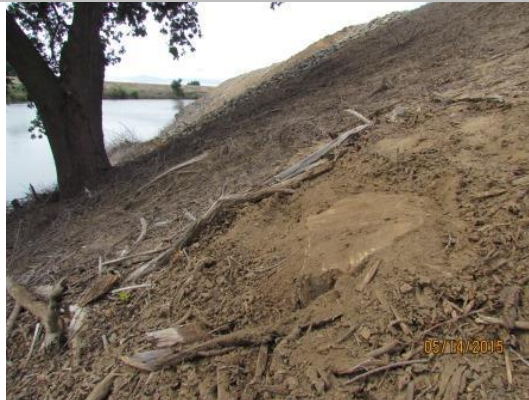
Photo 1 of 1 : SP_2018_RD0001_23_12_20180323_00010.jpg

LM Start	0.17	Rating **	N	Issue No.	12
LM End	0.17	Issue Type +	Ma	Location *	WS
Category	Earthen Levee			GPS Latitude/Longitude	
				Start	End
Item	Trim / Thin Trees			37.821376 °	37.821376 °
				-121.378044 °	-121.378044 °
DWR ID	DWR_RD0001_01_s_2014_12				
Comment Code					
T5 : Tree stumps.					
Inspector Comment					
Remove stump when it becomes rotted to prevent possible seepage path along the roots.

View of the tree stump on the waterside levee slope.

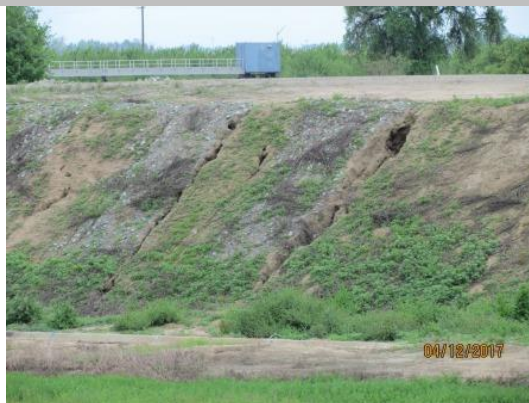
Photo 1 of 1 : SP_2018_RD0001_23_18_20180323_00013.jpg

LM Start	0.21	Rating **	M	Issue No.	18
LM End	0.21	Issue Type +	Ma	Location *	LS
Category	Earthen Levee			GPS Latitude/Longitude	
				Start	End
Item	Erosion / Bank Caving			37.820806 °	37.820806 °
				-121.378260 °	-121.378260 °
DWR ID	DWR_RD0001_01_s_2017_18				
Comment Code					
E2 : Schedule repair of erosion site prior to the next inspection.					
Inspector Comment

View of the erosion on the levee slope.

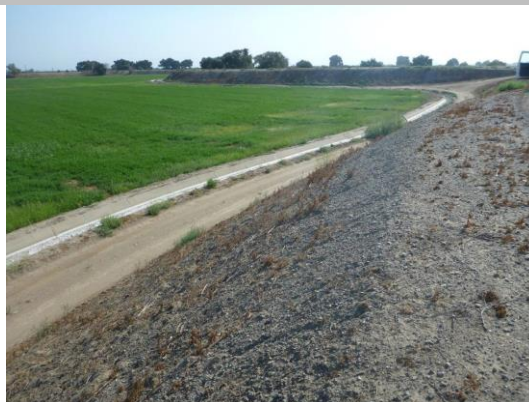
Photo 1 of 3 : LEVAL_SP_2018_496_4367.jpg

LM Start	0.31	Rating **	M	Issue No.	11
LM End	0.33	Issue Type +	Ma	Location *	
Category	Supplemental			GPS Latitude/Longitude	
				Start	End
Item	2017 Storm Damage			37.820300 °	37.820200 °
				-121.379500 °	-121.379800 °
DWR ID	DWR_RD0001_01_f_2017_11				
Comment Code					
Inspector Comment					
Levee Evaluation Comments					
Description:Slope protection repairs are needed along the waterside slope due to erosion and riprap displacement from high water. Based upon levee inspections, it was determined the waterside levee slope is eroding, deteriorating, and degrading. The eroded levee sections need to be restored back to design standards to prevent further deterioration and damage.					
Site ID No:496					
Site Designation:LMA-402					
Repair Type: Erosion					
Rating:Area of Concern					
Field Date:8/18/2017					
Notes: Start of outside bend. Minor toe erosion has displaced riprap.

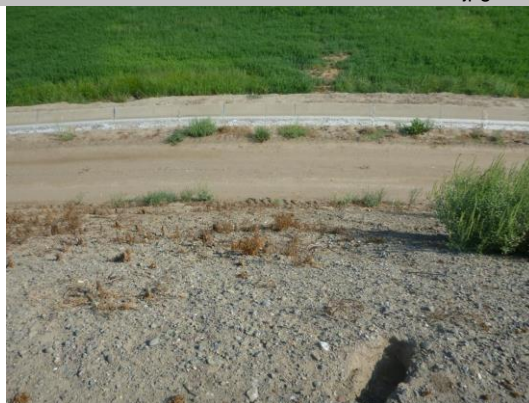
Photo 2 of 3 : LEVAL_SP_2018_496_4371.jpg

LM Start	0.31	Rating **	M	Issue No.	11 (cont)	
LM End	0.33	Issue Type +	Ma	Location *		
Category	Supplemental			GPS Latitude/Longitude		
				Start		End
Item	2017 Storm Damage			37.820300 °		37.820200 °
				-121.379500 °		-121.379800 °
DWR ID	DWR_RD0001_01_f_2017_11

Comment Code						
Inspector Comment						
Levee Evaluation Comments						
Description:Slope protection repairs are needed along the waterside slope due to erosion and riprap displacement from high water. Based upon levee inspections, it was determined the waterside levee slope is eroding, deteriorating, and degrading. The eroded levee sections need to be restored back to design standards to prevent further deterioration and damage.						
Site ID No:496						
Site Designation:LMA-402						
Repair Type: Erosion						
Rating:Area of Concern						
Field Date:8/18/2017						
Notes: Start of outside bend. Minor toe erosion has displaced riprap.

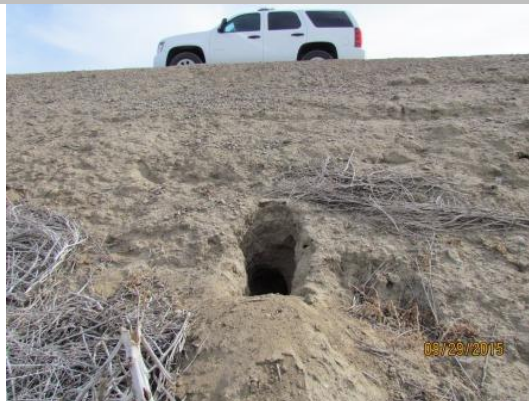
Photo 1 of 1 : SP_2018_RD0001_23_4_20180323_00003.jpg

LM Start	0.76	Rating **	U	Issue No.	4
LM End	0.76	Issue Type +	Ma	Location *	LS
Category	Earthen Levee			GPS Latitude/Longitude	
				Start	End
Item	Animal Control			37.815881 °	37.815881 °
				-121.382704 °	-121.382704 °
DWR ID	DWR_RD0001_01_f_2015_4				
Comment Code					
A1 : Exterminate rodents and backfill and compact or grout burrows.					
Inspector Comment					
Large burrow in the landside levee slope. Possible fox den. Cobwebs are visible in the hole. Fall 2016.

View of a large rodent hole on the landside levee slope.

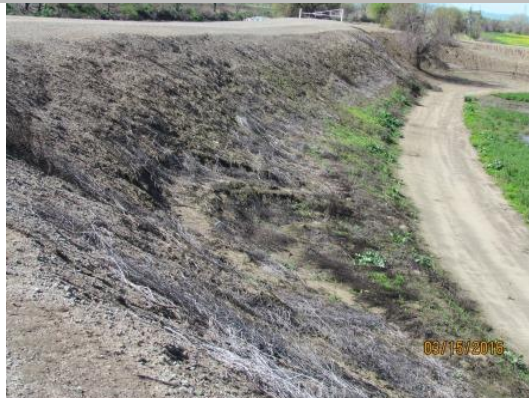
Photo 1 of 2 : SP_2018_RD0001_23_3_20180323_00001.jpg

LM Start	1.08	Rating **	M	Issue No.	3
LM End	1.08	Issue Type +	Ma	Location *	LS
Category	Earthen Levee			GPS Latitude/Longitude	
				Start	End
Item	Slope Stability			37.812023 °	37.812023 °
				-121.383961 °	-121.383961 °
DWR ID	DWR_RD0001_01_s_2016_3				
Comment Code					
S3 : Repair the levee slope damaged by vehicle traffic and prevent access where possible.					
Inspector Comment					
Repair slope damaged by vehicle by placing and compacting acceptable levee material.

View of the landside slope damaged by farm equipment.

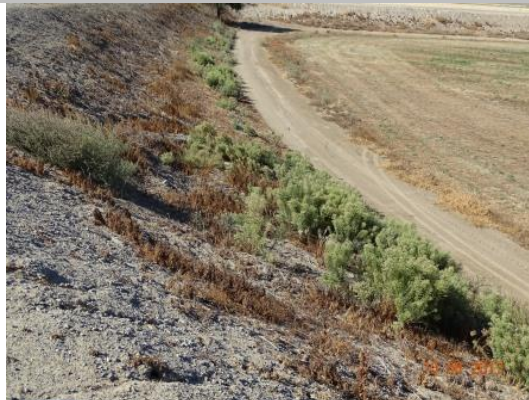
Photo 2 of 2 : SP_2018_RD0001_23_3_20180323_00002.jpg

LM Start	1.08	Rating **	M	Issue No.	3 (cont)
LM End	1.08	Issue Type +	Ma	Location *	LS

View of the ruts on the levee slope overgrown with vegetation.

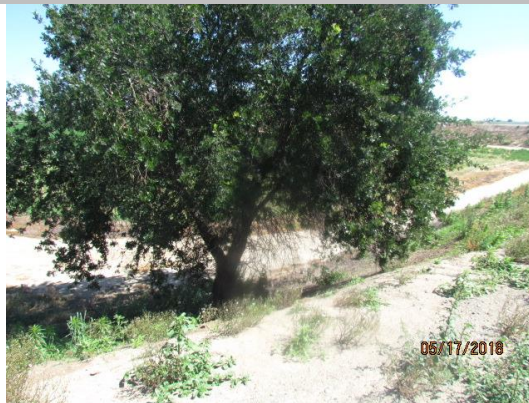
Photo 1 of 1 : SP_2018_RD0001_23_19_20180521_00022.jpg

LM Start	1.13	Rating **	M	Issue No.	19
LM End	1.13	Issue Type +	Ma	Location *	LS
Category	Earthen Levee			GPS Latitude/Longitude	
				Start	End
Item	Trim / Thin Trees			37.811714 °	37.811714 °
				-121.384876 °	-121.384876 °
DWR ID	DWR_RD0001_01_s_2018_19				
Comment Code					
T1 : Trim trees to at least five feet above ground level.					
Inspector Comment

Looking west at untrimmed tree at landward toe. (Spring 2018)
